HEAVY MAINTENANCE FOR SOFIA - CHALLENGES IN OVERHAULING AN OLDER AND HEAVILY MODIFIED AIRPLANE

H.T. Hammes, Deutsches Zentrum für Luft- und Raumfahrt - Raumfahrtmanagement,
Königswinterer Straße 522-524, 53227 Bonn, Deutschland

A. Britz, Lufthansa Technik AG - VIP & Executive Jet Maintenance,
Weg beim Jäger 193, 22335 Hamburg, Deutschland

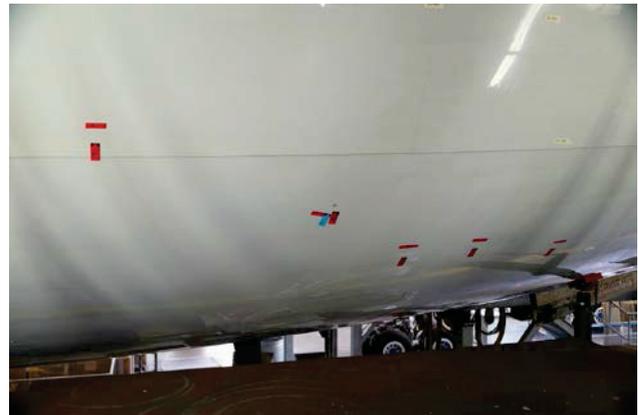
Very soon after docking SOFIA started to become sprinkled with a lot of decals. These decals in different colors denoted findings which became apparent during inspections. They included dents in the fuselage, cracks in structures, missing bolts, leaks of any kind ... etc.

Bild 8. FINE decals on the fuselage.

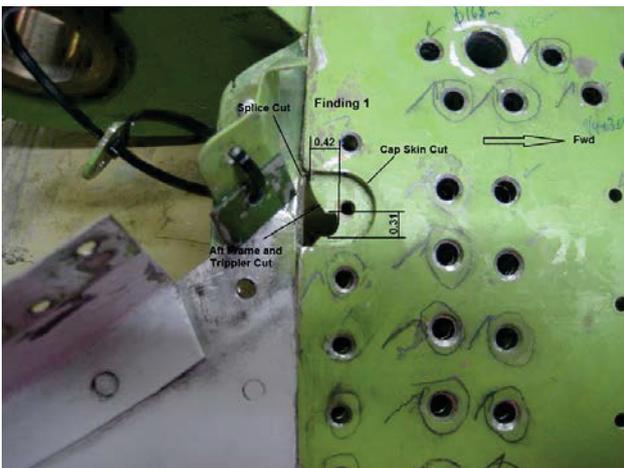
In the engine pylon for the #3 engine the LHT-team detected an interesting accumulation of findings. Older cracks were covered by doublers or even a tripler; bolt-holes were found to be either out of size or out of drawing tolerances; repairs showed damages and needed to be repaired again.

Bild 10. Example of findings on #3 engine mount. Finding is marked, measured and damages are described. Bolt-holes within tolerances are checked.

The LHT-engineering team proposed several approaches for repair to Boeing. None of these were approved and different repair procedures were sent by Boeing. The Boeing-procedures were technically not feasible and LHT sent new proposals to Boeing. It took six weeks to reach an agreement how to perform the repairs and prepare the necessary documentation for airworthiness certification.

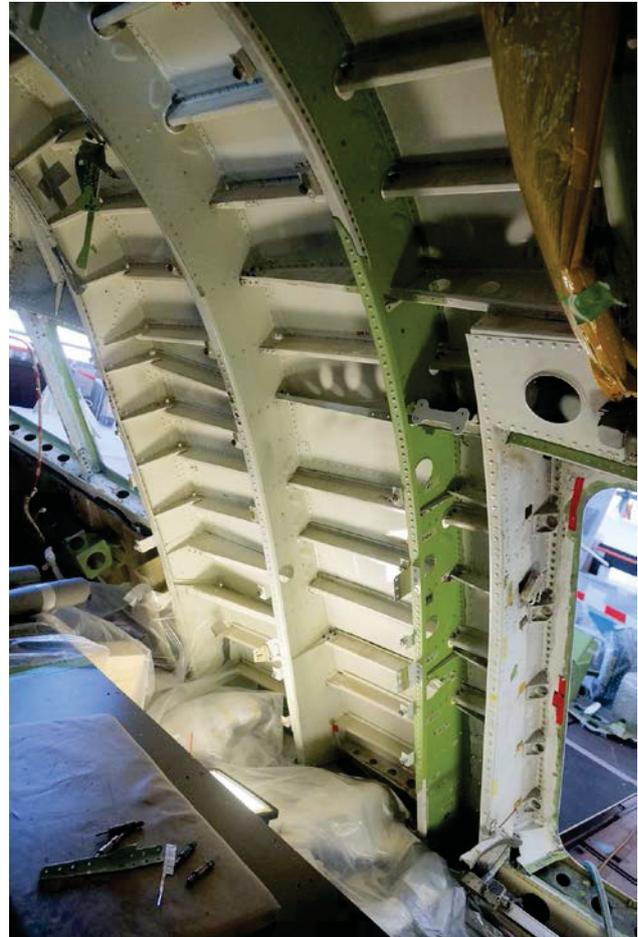
Bild 11. New Frame RH380 (green) installed.

Removal of frame RH380 and repair of frame RH360 proved to be straightforward compared to the work on the engine mounts. Both frames were removed and either repaired at the LHT-facility (RH360) or replaced with a new frame sent by Boeing (RH380). However, in order to be able to access the frames, the flight engineer station in the cockpit as well as all the wiring had to be removed.

With a three-shift operation for three weeks LHT managed to de-install and repair/replace the frames.

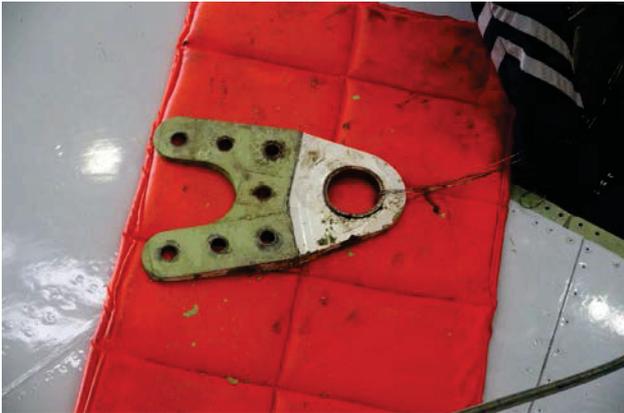
The RH wing gear support end fitting was a very interesting example of a finding. During structural inspections of the wing to fuselage area, LHT-mechanics noticed the peculiar position of this fitting. They checked drawings and other technical documentation and eventually determined the fitting was installed in the wrong orientation; it needed to

be flipped 180°. In addition, a shifting of the bushing was noted. This kind of finding had never been reported on a B747SP. LHT therefore asked for a procedure to replace the fitting. Boeing sent the procedure which contained the sequence for removing connecting bolts and bearings. They also sent an instruction to pull the beam, which held the fitting at its end, sideways with a force of 1000 pounds; then the beam was supposed to come free. This indeed happened as prescribed. With a sling the necessary force was applied to the beam and the fitting came free.

Bild 12. RH wing gear support end fitting removed.

In order to reach the fitting the mechanics dismantled large portions of this wing-area. In addition, they removed hydraulic lines and control cables until the fitting was accessible. All of this took weeks to complete.

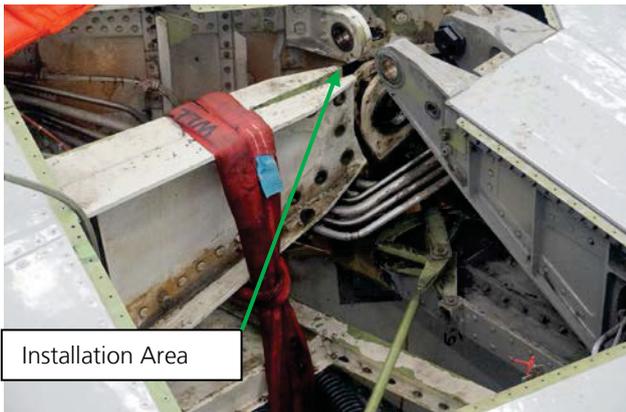
Bild 13. Installation area of RH wing gear support end fitting.

As we had concerns about the same fitting on the LH wing, it was removed and replaced with a new one too.

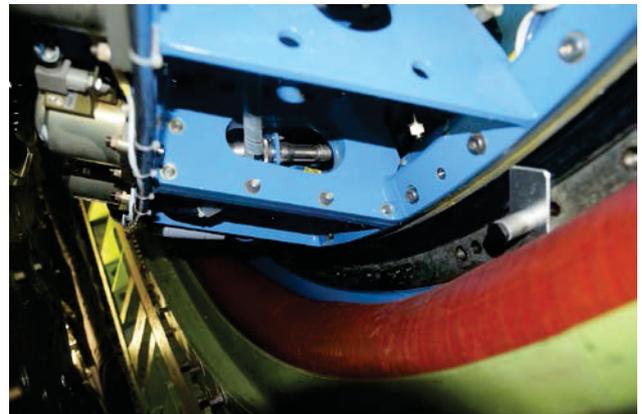
Bild 14. Main seal assembly (in orange) of the TA. This seal is bolted both to the aircraft-bulkhead and to the TA. It provides the first level of protection for the cabin.

- Exchange of all air springs and damping elements of the vibration isolation system
- Replacement of three of the four pressure/temperature seal levels that isolate the cavity environment from the cabin
- Maintenance, repair, and improvement of all pressure, hydraulic, and electronic systems
- Exchange of shims for the holding structure of the Secondary Mirror.

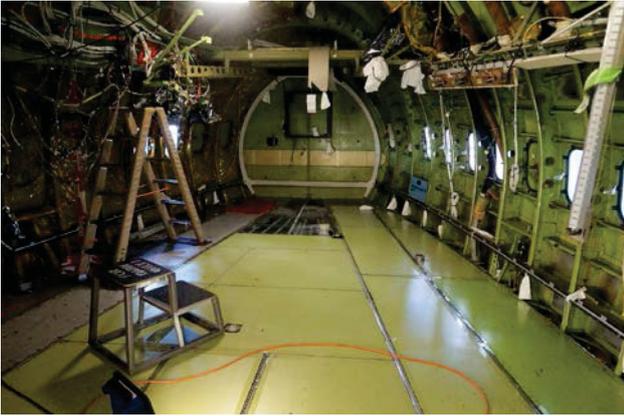
Most of the seat-tracks in the aircraft had to be replaced due to cracks and corrosion in their structure. This proved to be a challenge, since all trades - including NASA and DSI – were eager to complete their work in parallel.

Bild 15. New floor and seat tracks in nose section.
