LAUNCH CAMPAGIN AND FLIGHT ANALYSIS OF THE DECAN AQUARIUS STUDENT ROCKET

Department of Aeronautics and Astronautics, TU Berlin, Marchstr. 12, PF: F6,
10587 Berlin, Germany, R.Lippmann@tu-berlin.de

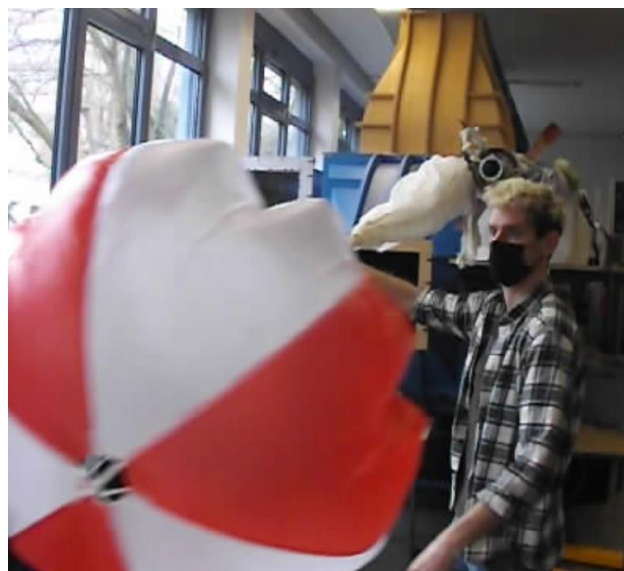
FIG 4. Parachute pull out test at the TU Berlin wind tunnel.

To qualify the system for flight and to confirm the ability of the small chute to pull out the main chute, wind tunnel tests were conducted at TU Berlin. FIG 4 shows the test setup during the parachute pull out tests. The wind speeds applied in the wind tunnel were calculated in the frame of a trajectory analysis prior to this investigation using the software ASTOS. After the test setup was finalized, the pyrotechnical actuator was triggered manually. This led to the successful release of the spring-loaded lid, followed by the small parachute being dragged into the wind tunnels air steam. The air stream was always able to completely open the first chute. Thereby, the small parachute always provided enough force to successfully pull out the main one, qualifying the system for flight.

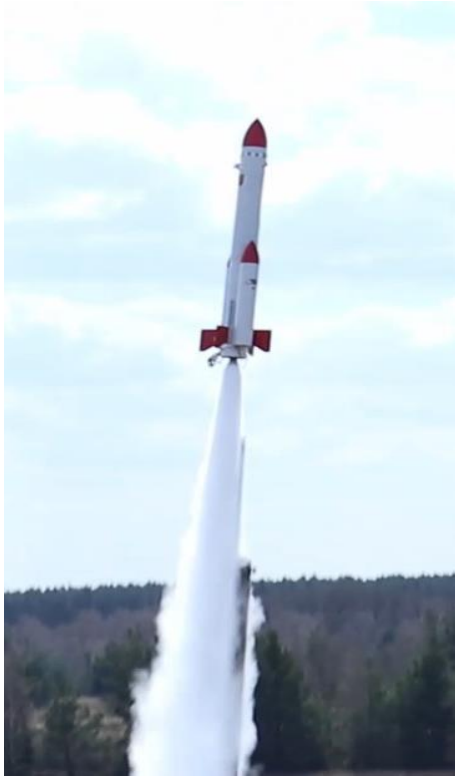
FIG 5. DECAN AQUARIUS leaving the launch tower.

system was triggered manually from a safe distance. The self-developed hot water rocket nozzle release MGSE worked as planned, finally qualifying the design. The DECAN AQUARIUS successfully left the tower after about one second and showed a stable and almost complete straight flight. FIG 5 shows the rocket ascending out of the launch tower.

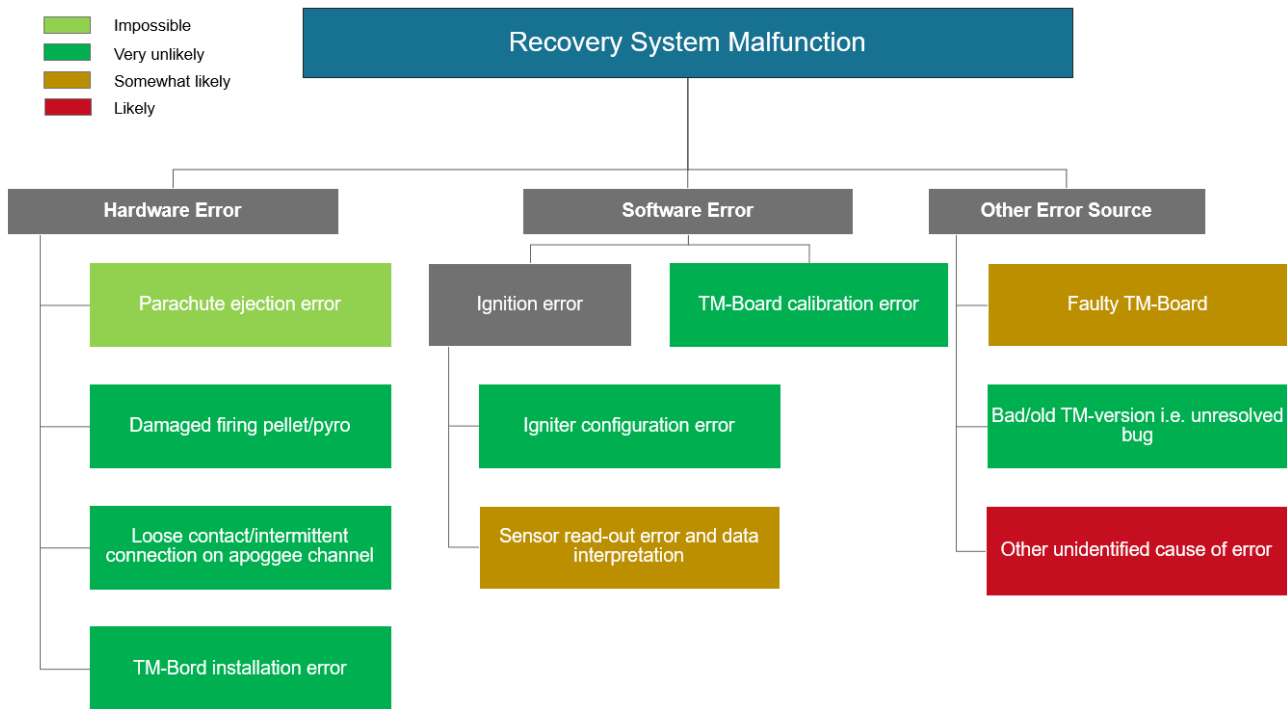
FIG 6. Possible recovery system malfunctions.

After the touchdown of the DECAN AQUARIUS, the possible faults of the recovery system malfunction were investigated. FIG 6 provides an overview of the potential defects including their likelihood.

Summarized, an error of the hardware components is very unlikely, since the telemetry unit was operated in the correct mode, the pyro and the corresponding ignition pellet were error free and voltage was available.

Summarized, a malfunction of the software is somewhat likely since the sensor read-out and data interpretation may have been executed incorrectly. This seems further likely since the setup and calibration of the telemetry unit have been carried out error-free.

seems further likely since a lot of possible errors could be evaluated as unlikely. Therefore, the investigation will be carried on in the next semester.
