# ROTOR ICING AND DE-ICING TESTS IN THE DLR ROTOR TOWER

R. Bartels, DLR, Institute of Flight Systems, Braunschweig, Germany  
O. Schneider, DLR, Institute of Flight Systems, Braunschweig, Germany  
M. Pohl, DLR, Institute of Lightweight Systems, Braunschweig, Germany  
R. Konrath, DLR, Institute of Aerodynamics & Flow Technology, Göttingen, Germany  
S. Galiana, DLR, Institute of Lightweight Systems, Braunschweig, Germany  
P. Marquardt, DLR, Institute of Aerodynamics & Flow Technology, Göttingen, Germany  
C. Postrach, DLR, Institute of Flight Systems, Braunschweig, Germany

The paper presents experimental rotor icing investigations in the DLR rotor icing test facility EVA (Eis-VersuchsAnlage) within the frame of the DLR project SAFER<sup>2</sup>. The project mainly addressed the challenges arising from the combination of sensor technology, machine learning methods, and artificial intelligence in the control of complex technical systems, with regard to functionality and operational safety. In this project, the rotor test stand inside EVA was one of five selected demonstrator platforms for gathering data for ML (Machine Learning) algorithms. In this case, the measurement data come

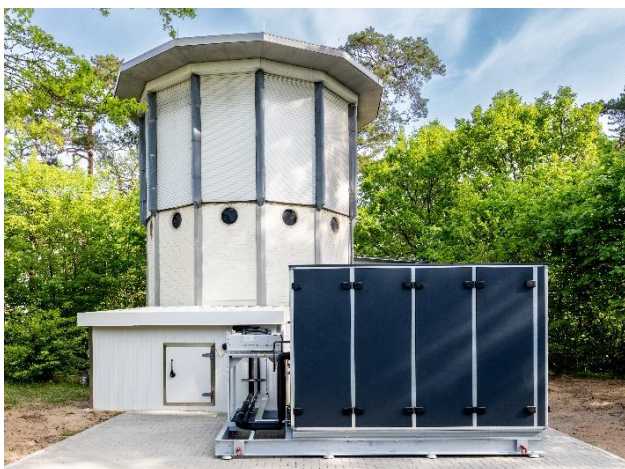
The DLR rotor tower (Figure 1), originally designed in the late 1950s for hover tests of model rotors with diameters up to  $D = 4.2$  m, is one of two rotor test facilities in Braunschweig.

Figure 1 DLR's rotor tower with the cooling system

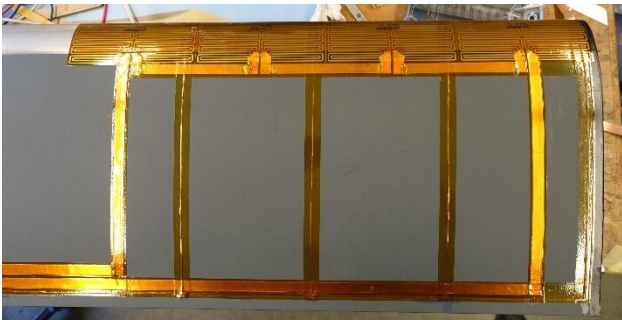
The new rotor system is equipped with heater elements. One blade can be used for anti-icing the other one for de-icing tests. The anti-icing blade has an electrical heater system with a maximum power of  $P_{max,ai} = 920 \text{ W}$ . Four heater foils are installed at the leading edge of the rotor blade starting from the 70 % radius position to the blade tip and up to 15 % chord at the upper side and 25 % chord at the lower side (Figure 7). They are connected in series and act as one single heater element. Under each foil a temperature sensor is mounted into the blade skin for monitoring purposes. Since the rotor blades are rejects from the Airbus Helicopters production line, the foil heaters are glued to the surface rather than integrated into it. For the same reason, the wiring is also located externally, rather than inside the rotor blades.

Figure 7 Anti-icing blade heater foils

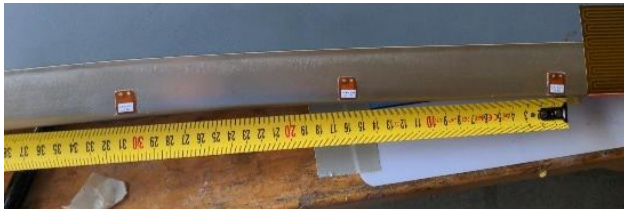
To assess the general feasibility of using Lamb waves to detect ice with Lamb waves traveling directly through the leading edge of helicopter rotor blades, an initial test was performed on a non-rotating section of a real rotor blade (Airbus H145). To transmit and receive Lamb waves, piezoelectric transducers were attached to the leading edge as shown in Figure 12. A distance of 15 cm is kept between each transducer to allow measurement distances of 15 and 30 cm.

Figure 12 Piezoelectric transducers added to rotor blade leading edge

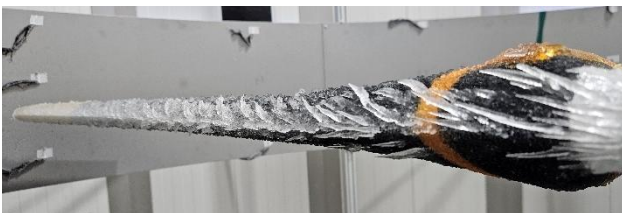
The ice shapes at the de-icing blade of test case *Ice-5* can be seen in Figure 20 and Figure 21. After five minutes of spraying, icing was present over the complete radius range, while at inner radii the thickness was about 5 – 8 mm, and thus less than at the outer region, where about 12 – 15 mm of ice could be observed.

Figure 20 Test case *Ice-5*: ice shape at the root of the de-icing blade

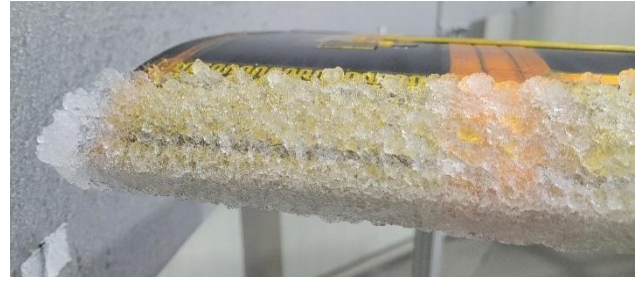
Figure 21 Test case *Ice-5*: ice shape at the tip of de-icing blade

After the rotor was stopped, it was observed that the rotor blade tip – which had previously been completely iced (shown in Figure 21) – was now free of ice in the radial area of the heater. The boundary between the remaining ice and the ice-free area coincides with the start of the heater, as visible in Figure 25, indicating the area where the ice cracked before shedding. The centrifugal force acting on the ice helped to shed it more quickly.

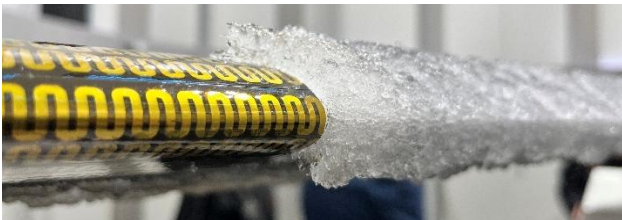
Figure 25 Test case *De-Ice-2*: ice shape after de-icing

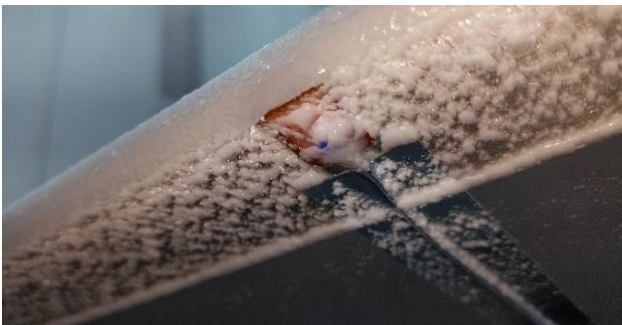
For the icing tests in EVA, the test blade was equipped with the same setup as describes previously in section 3. Multiple icing tests were performed where an ice accretion was visible every time on the test surfaces as shown in Figure 26.

Figure 26 Ice accretion on LILD transducer and test surface
