HEAVY MAINTENANCE FOR SOFIA - CHALLENGES IN OVERHAULING AN OLDER AND HEAVILY MODIFIED AIRPLANE

H.T. Hammes, Deutsches Zentrum für Luft- und Raumfahrt - Raumfahrtmanagement,
Königswinterer Straße 522-524, 53227 Bonn, Deutschland

A. Britz, Lufthansa Technik AG - VIP & Executive Jet Maintenance,
Weg beim Jäger 193, 22335 Hamburg, Deutschland

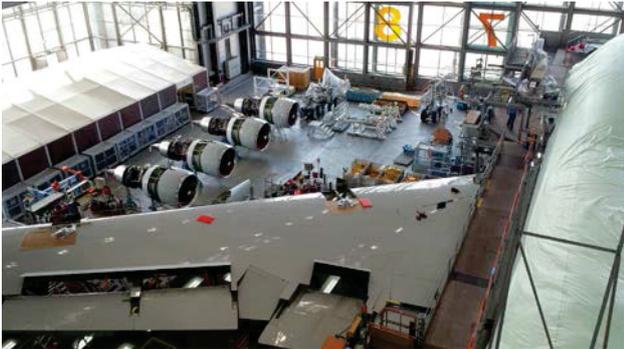
- all four engine mounts; with #3 requiring special repair procedures from Boeing
- RH wing gear support end fitting
- all air-conditioning and system-air distribution ducts
- most seat tracks
- all doors
- trimming and adjustment of all control surfaces
- check and partial rerouting of the electrical wiring interconnection system (EWIS)
- exchange or repair of most bearings/bushings/sleeves in wing- and tail-control surfaces
- extensive rework of cabin installations like flooring, insulation mats, sidewall panels.

Bild 9. SOFIA in Dock, engines removed (left).

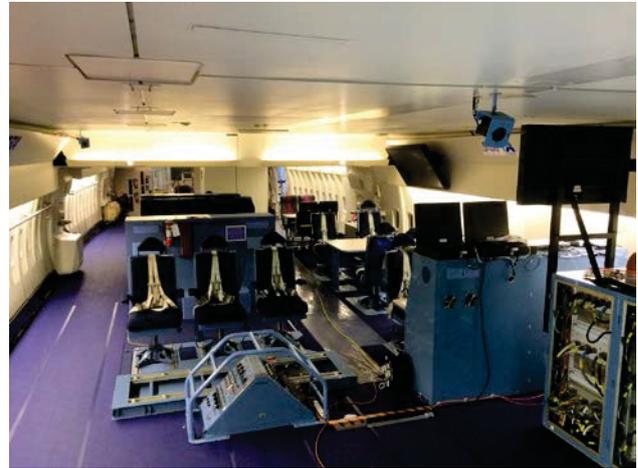
LHT also replaced the 30 year old seats which were used up to the HMV. They installed surplus business class seats in the nose section and upper deck. Last but not least all lavatory-equipment was replaced or refurbished. With these changes the cabin now looks more like an airliner than a research plane.

Bild 16. Improved cabin interior with new floor matting, side and ceiling panels and lighting.

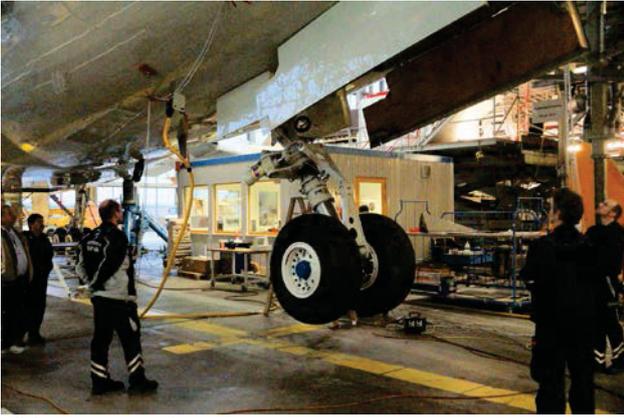
Verification of the new landing gear consisted of a so called "gear swing". The purpose of this test is to confirm correct and timely opening of the doors and swinging the landing gears into the correct position.

Bild 17: Gear swing of nose gear
