EVALUATION OF A VISUAL ASSISTANCE SYSTEM TO SUPPORT MANUAL SCARF REPAIRS FOR A DIGITALIZED AIRCRAFT MAINTENANCE

R. Schmücker¹, A. Wilken¹, J. Kosmann², D. Holzhüter²

¹Institute of Maintenance, Repair and Overhaul, German Aerospace Center, Germany

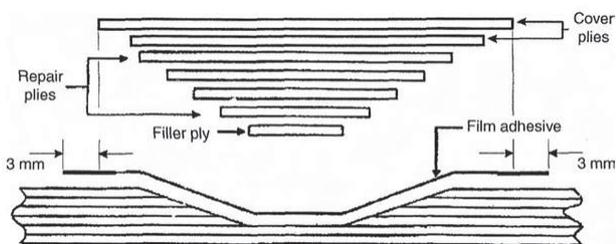
FIG. 1 Structure of a tapered scarf repair [3]

If a damage occurs, the structure is mostly repaired based on the manual tapered method, depending on how extensive the damage is, where is it located on the structure and it is still classified as repairable after the structural repair manual (SRM). [3] In this process, the individual material layers around the centre of the damaged area are removed from the technician with a hand-grinder and then rebuilt by inserting several fibre layers, see FIG. 1. [2]

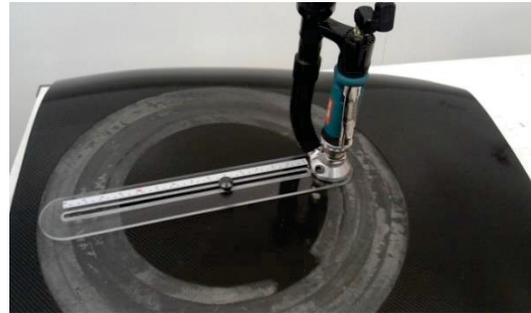
FIG. 2 Toolkit for stepped scarf repairs [4]

Mechanical devices can be used to support the hand-guided process, see FIG. 2, here in the form of

a toolkit for a stepped scarf repair, which guides the grinder for increased accuracy during the grinding process. [4]

In contrast to the tool kit from FIG. 2, various systems have been developed in recent years in the area of research for a partially or fully automated scarf procedure. At this point a short overview of two selected systems follows.

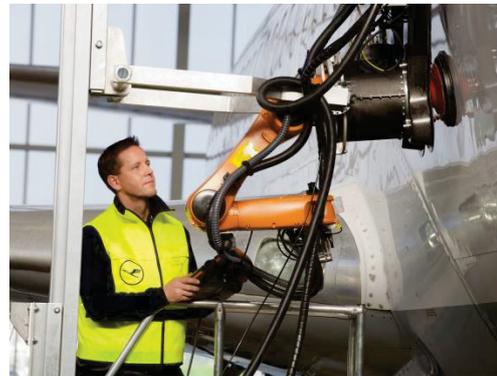
The system in FIG. 3 is built up within the *LuFo* projekt "CAIRe" (FKZ 20W1101A) and consists of a portable robot arm which is mounted directly on the damaged structure via suction cups and is equipped with a milling unit. A laser scanning system allows to scan the surface and based on this data the software calculates the travel path for the implemented milling unit which creates the scarf geometry automatically. [5]

FIG. 3 Automated scarfing with CAIRE System [12]

Fully automated systems such as *CAIRe* are particularly suitable for the repair of major damage to large fuselage or wing segments which either cannot be disassembled or at least not without increased workload. The system from the *Supcrafted* project is also specially designed for on-wing repairs, but initially for slightly curved structures.

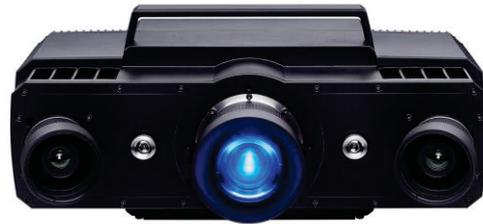
FIG. 5 GOM Atos 5 system [9]

The ATOS 5 [9] system, see FIG. 5, from GOM provides the best results, not at least because of its encapsulated housing [9] whereby the system has a significant advantage which allows its usage under real industrial conditions. Thus the system is safe from CFRP dust which occurs during grinding. The dust can be electrically conductive and can lead to short circuits of exposed electrical components. [10] After the surface is scanned by the structured light projector, the software interface allows to programm various application for calculating geometric bodies or contours. So the scanned surface and the calculated bodies/contours can be combined or compared within a deviation analysis for example. It's also possible to reproject these geometric contours and visualizes them on the component surface, see the example in FIG. 15 in chapter 7.1. It is one of the important functions to realize visual support during the scarfing process.

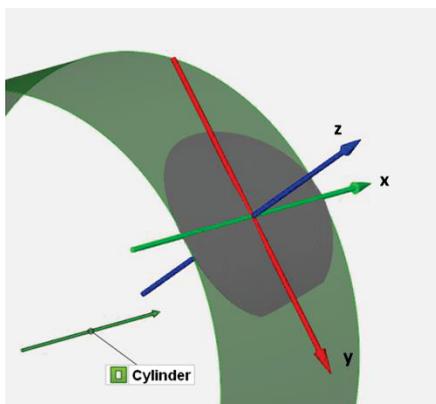
First of all the original surface is scanned. It needs to have some glued on reference points around the assumed outer contour of the scarf. These are necessary to calculate the relative orientation between object and scanner in all coming steps. Furthermore a coded reference point has to be in the middle of the damage, another on the outside of the maximum scarfing distance. Based on the coded points the surrounding area is deleted and the initial surface is calculated. The coordinate system is centered in the middle of the damage and is orientated by using a fitting cylinder. The x-axis is orientated towards the non-curved direction, the y-axis towards the curved direction and the z-axis is perpendicular to the surface, see FIG. 7

FIG. 7 Scanned surface (grey) with reference points and coordinate system oriented by a fitting cylinder (green)

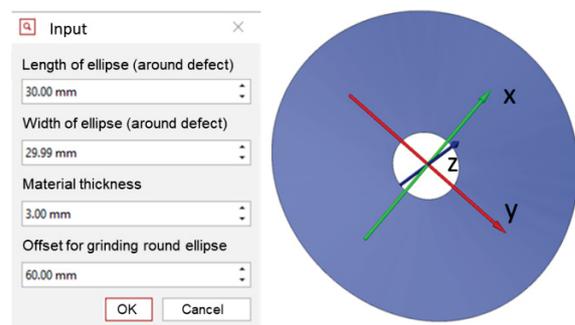
Secondly, a user input window asks for the scarfing parameters. Based on this, the inner and outer ellipse (or circle) are generated. The inner contour has a constant offset in the negative z – direction in the amount of the material thickness. Then the outer and inner curves are connected to create a taper geometry (in the first test series outer and inner contour are linear connected as simplification). Based on this a point-cloud for the nominal scarf geometry is generated. In the subsequent step this point-cloud is meshed and smoothed to become the nominal scarf structure. It contains the information of the reference points and the coordinate system.

FIG. 8 User input window (left) and nominal scarf contour (right)

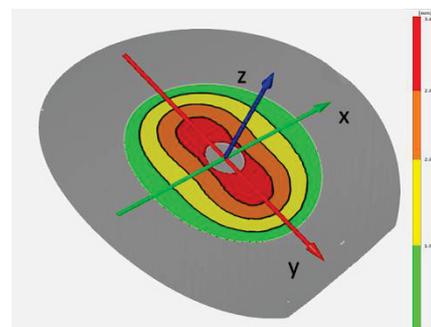
The next step is to compare the nominal contour to the actual scanned surface. The result is then displayed as a color plot with level lines. The calculated level lines can be reprojected with ATOS 5, shown later in FIG. 15. [9] The software automatically corrects the distortion, as long as at least three reference points are located in the projection area.

FIG. 9 Deviation between scanned and nominal surface, max. grinding depth = 3.6 mm (red area)

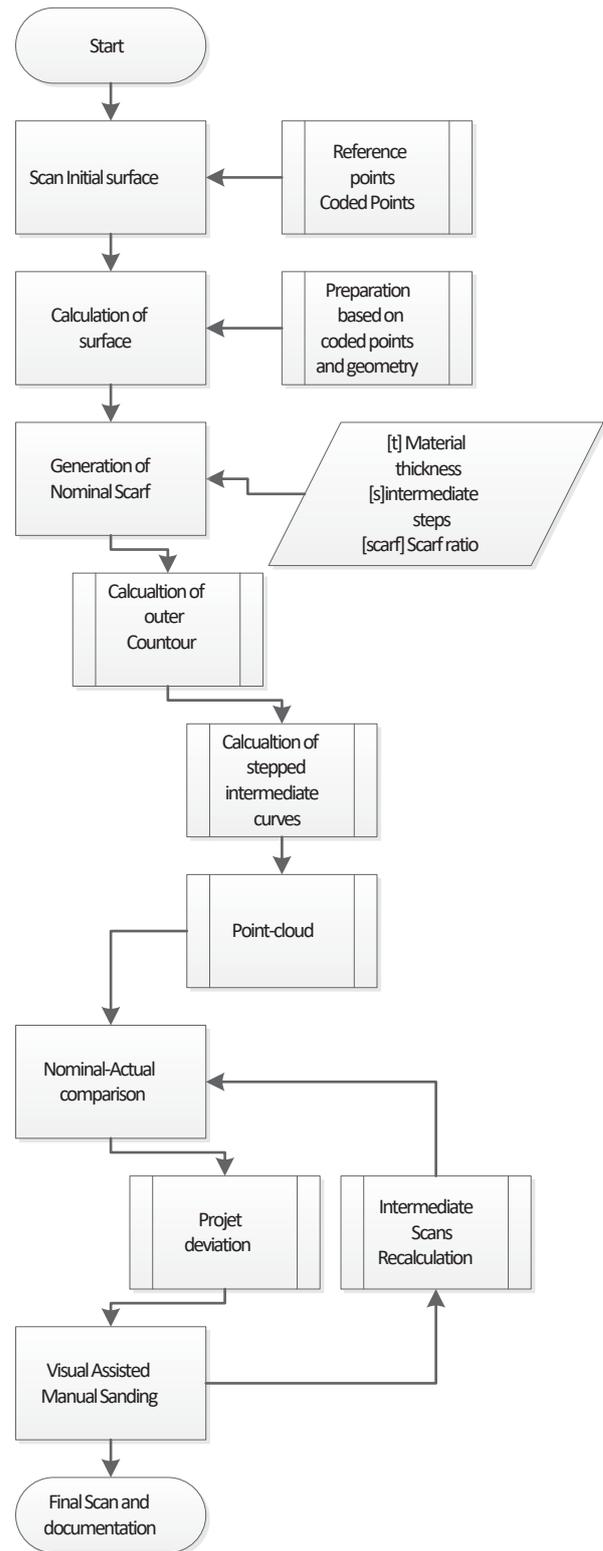
FIG. 10 Workflow of the calculation program for assisted scarf repairs

To be more flexible by generating individual scarf geometries, the program was adapted so that the inner scarf contour can be additionally set with manual input depending on the damaged area. The outer contour is creating by an offset parameter around the inner contour. The process step "Calculation of stepped intermediate curves" in FIG. 10 signals the adapted method to connect the outer with the inner contour to create a smoother tapered geometry. So now the user can set intermediate steps between the single scarf contours to adjust the tapered scarf geometry to curved structures, see FIG. 17 in chapter 7.3.

FIG. 10 shows the complete workflow within the calculation program for the assisted grinding process.

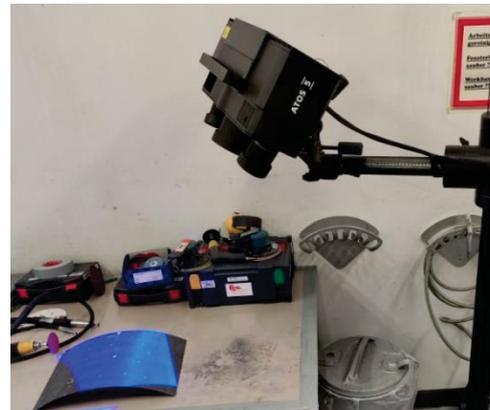
FIG. 12 shows the test setup for assisted scarfing with the *GOM ATOS 5*. The tests were carried out in a separate workshop area of Lufthansa Technik (Hamburg) with the room lighting switched on in order to evaluate the visibility of the projections on the surface under realistic conditions.

FIG. 12 Test setup for assisted scarfing process at Lufthansa Technik (Hamburg) on single curved CFRP samples [12]

The measuring system requires an additional computer with a corresponding software package, which is connected to the scanner via a control unit. After the damage location has been defined on the CFRP sample, it has to be prepared with optical markers which are glued on around the damaged area.

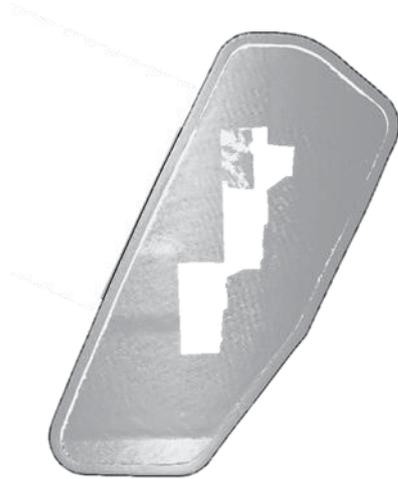
FIG. 13 Complete scarf contour of second pilot test in GOM Software

this time, due to the limited field of view of the assistance system, the overall scan surface has to be composed from several partial scans using glued markers. In addition, the further development of the software application within the individual manual curve generation method, see the end of chapter 5, is tested. The following FIG. 13 shows the complete scarf contour within the software interface from GOM. In the end, the findings during the test are discussed with the experts from Lufthansa Technik.

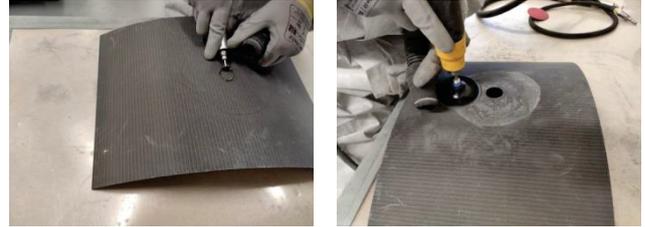
FIG. 14 View during the unassisted scarfing process [12]

In the conventional scarfing process, the technician uses a marker to transfer the nominal contour to the structure, with using a circular template for the outer radius of the scarf contour. A compressed air grinder is used for the implementation.

During grinding, the technician orientates himself on the light reflection of the fibre layers which signals the different fibre orientation and checks the

intermediate status by touching along the grinded contour combined with a visual inspection. Cause experienced and well-trained technicians are able to assess the quality of their work very well themselves and thus meet the requirements for repair.

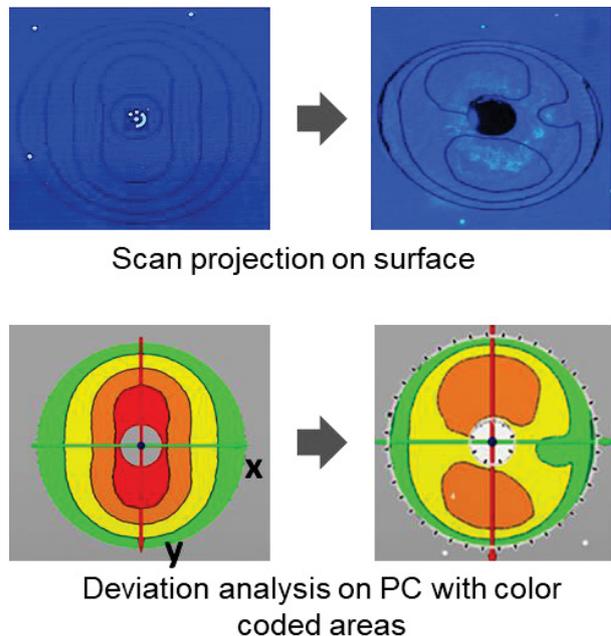
FIG. 15 shows intermediate statuses during the assisted scarfing, with the first figure showing the initial situation before the grinding process begins. By means of the coded marker in the centre of the damaged area, the software detects for which area of the previously measured component surface the nominal scarf geometry should be calculated. Due to the hardware limitation of the GOM ATOS 5, the reprojection of the calculated nominal geometry is realized with two colors. The colored deviation analysis is shown on the computer display within the ATOS software [11].

FIG. 15 Initial and intermediate status of the assisted scarfing process

The number of scans for the analysis of the current status was freely chosen by the technician. The contours adapt to the respective status of the scarf and indicate the current deviation from the nominal geometry in mm via the colored scaling.

geometry results in an elliptical formation of the contour lines in the direction of Y, see FIG. 15 (lower left). The contour should correctly be circular. This has the effect that too much material is removed in the marked area (FIG. 17) due to an incorrect deviation analysis between nominal and as-is status.

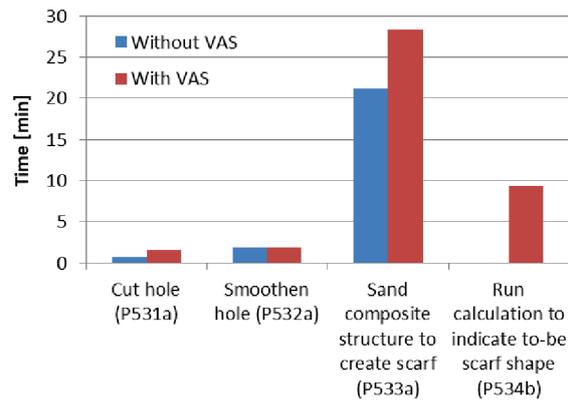
As mentioned in chapter 6.1, the individual process times were recorded during the first test series. FIG. 16 shows the time intervals for the scarf process. The time for evaluating the intermediate status during the unassisted scarfing is included in process step P533a, since the technician carries out his evaluation within a few seconds and resumes the grinding process immediately.

The time required to cut out the center of the damaged area differs only marginally, whereas the grinding process P533a with the assistance system increased by 34% to 28 minutes compared to the unassisted process.

FIG. 16 Comparison of time values between unassisted and assisted grinding

In addition, the technician needs 7 minutes for the first initialization and projection of the scarf geometry compared to the 2 minutes required for marking with a color marker. Due to the recording and calculation of the intermediate statuses, the entire process is extended by a further 10 min (P534b) to a total of 50 min. This increases the time for scarfing within this test series from 27 min (unassisted) to 50 min (assisted). A part of the additional time required can be explained by the fact that the technician was using the system for the first time for scarfing and wanted to work as accurately as possible with the help of the system. Currently some manual process steps must be performed by the technician which could be reduced to a minimum by a better workflow within the program, remind FIG. 10. So together with the system set-up at the beginning, the increased time expenditure can be explained. But it is therefore assumed that once a technician is fully familiar with the system, the time differences could be decrease.

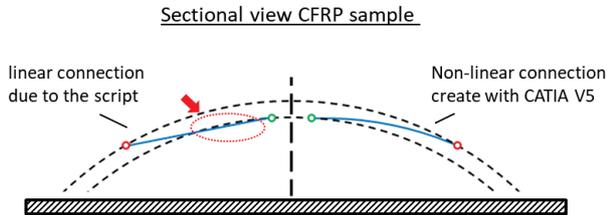
First of all, an effect from the calculated nominal geometry by the programmed script has to be explained. The calculated nominal geometry for the assisted repair was generated with a simplification, see 5 (2). The following sketch in FIG. 17 shows the difference between the calculated nominal geometry by the programmed script and the designed nominal geometry with *CATIA V5*. Because the inner and outer contours are linearly connected in the script to create a tapered scarf geometry (initial simplification), the curvature of the nominal

FIG. 17 Sketched section view of the nominal geometry from the script (left) and designed with CATIA (right)

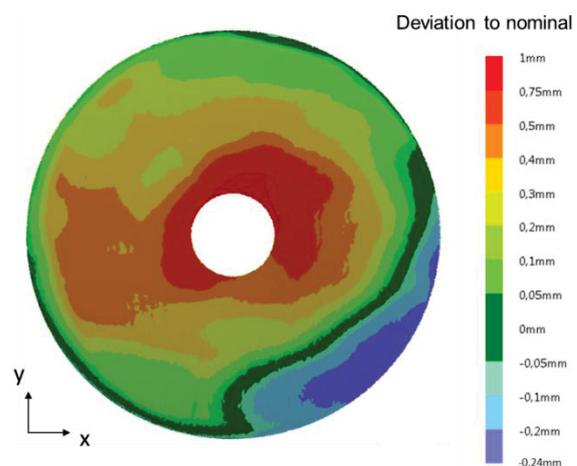
FIG. 18 DA No.1, unassisted scarf vs. designed nominal geometry (non-linear connected, compare FIG. 17)

For a DA, the reference surface has to be positioned correctly into the point cloud of the scanned as-is surface. While the nominal geometry of the assisted scarf is positioned by the script, the nominal geometry of the unassisted scarf has to be positioned by a best-fit procedure. Furthermore the nominal geometry for the unassisted grinding has to be designed afterwards, because it wasn't intended to use the assistance system. Therefore only the final geometry was scanned and thus only the outer tapered contour of the final geometry is used for designing and positioning the nominal geometry for a deviation analysis. The results can be seen in FIG. 18 and FIG. 19.

Both analyses show the final deviation in mm from the required nominal geometry. The deviations from the nominal geometry can be derived from the resolution of the color scales. Light green – dark green areas indicate that the nominal geometry has been reached, orange – red indicates that material has yet to be removed and blue – purple indicates that too much material has already been removed. The DA in FIG. 18 shows quite good results, especially in the outer areas. This might be caused by the fact, that the technician has many years of experience, however it also becomes obvious that

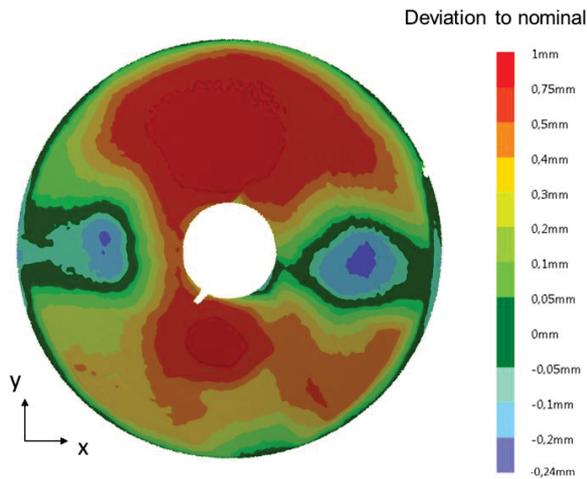
FIG. 19 DA No.2, assisted scarf vs. calculated nominal geometry (linear connected, compare FIG. 17)

It is noticeable that the color pattern of the second deviation analysis in FIG. 19 shows an irregularity. The red colored areas in y - direction can be explained by the order, not to grind further material away. At this point the negative effect of the simplified geometry as described before became apparent. According to the assistance system, the technician should have partially grinded away the last layer of CFRP at these areas. Nevertheless the maximum deviation is also up to 1 mm, just as with the unassisted scarf geometry.

Due to the minimal curvature in x – direction, the deviation analysis is evaluable in these areas and shows deviations around ± 0.2 mm to the nominal geometry. Important at this point is that the technician can hardly estimate when, for example, 0.2 mm of material has been removed. Due to the usual mechanical vibrations during grinding, it is difficult to recognize if a material thickness of 0.2 mm has been removed, according to the expert. However, in order to make an exact statement about the tolerances to be achieved with the assistance system, further test series would have to be carried out in the future.

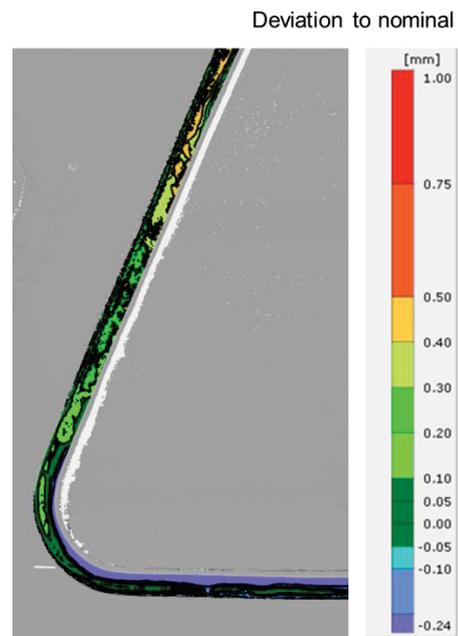
FIG. 20 In-Situ DA of assisted scarf vs. calculated geometry

The second test series essentially showed that a large scale support requires significantly more time for the initialization of the complete surface. But the implemented method to generate an individual scarf contour has worked well, so the system can be used more flexible for different damage scenarios in the future. During the grinding process, the feedback from the technician regarding the presentation of a deviation analysis was very positive. Due to the complex and large CFRP structure, it is a quite difficult tasks for the technician and requires a high level of concentration for a long time period, so he was glad to be able to check his work status via the assistance system. The DA in FIG. 20 shows a part of the lower left corner of the complete scarf contour during the grinding process. As in the DA's from FIG. 18 and FIG. 19, the light green to dark green areas indicate similarly good results of the deviation from the nominal scarf contour about only 0 - 0.2 mm. But in contrast to the first test series, the component in FIG. 13 has different material thicknesses around the calculated scarf contour. This thickness variation cannot be considered by the system so far, so that some areas such as the purple colored, show inaccuracies.
